# Manhole Inspection Summary

## Manhole # S15AA1018MH

Insp Date: **6/15/07 9:50 AM**

**Location** Address: **3755 REISTERSTOWN RD** Cross Street: **SPRINGHILL AVE**

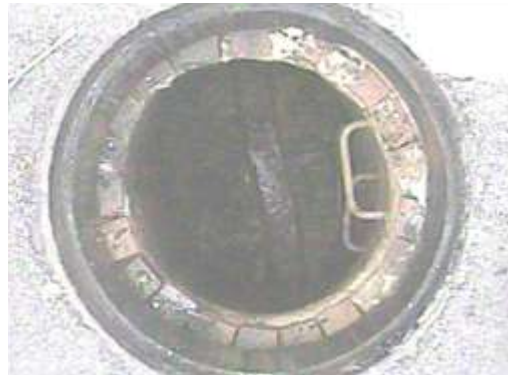
Top View

**Frame** Offset: **3** (in.) Condition: ☒ Sound ☐ Cracked ☐ Leaks

FRAME OFFSET

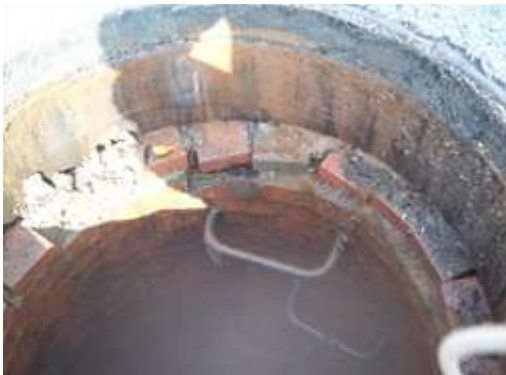
Defect 2

**Chimney / Frame Adjustment** ☒ Exists Material: **Brick** ☐ Parged Height: **2** (in.)  
Condition: ☐ Sound ☐ Cracked ☐ Root Intrusion ☒ **Loose Brick** ☒ **Deteriorated**  
Infiltration: ☒ None ☐ Joint ☐ Cracks ☐ Mortar ☐ Roots ☐ Wall

LOOSE BRICKS- FRAME ADJUSTMENT

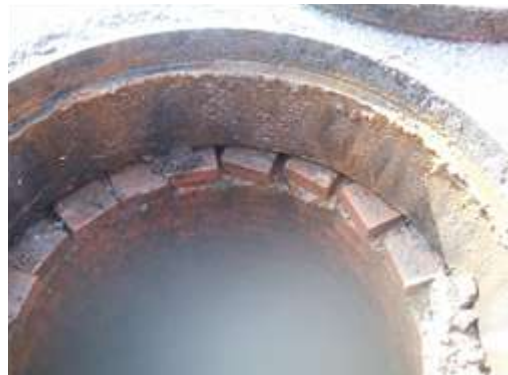
Defect 1

DETERIORATED CHIMNEY/FRAME  
ADJUSTMENT

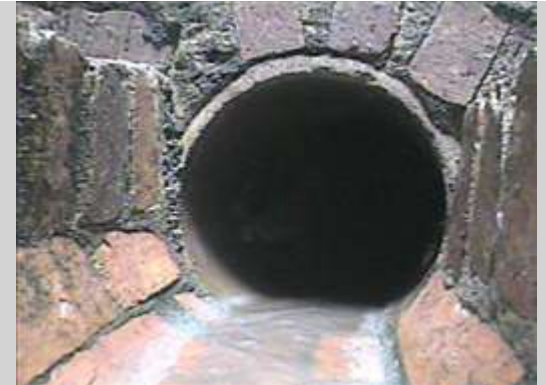
12 O'Clock Outflow

8 in. Circular Gravity Sewer  
Pipe Out @ 12 O'Clock

Pipe Height: (in.) Direct  
Pipe Material: **Clay** ☐ Pipe Lined  
Invert Depth: **7.24** (ft.) Flow Characteristics: **Slow**  
Deposits: ☒ None ☐ Mud ☐ Sludge ☐ Debris ☐ Grease  
Silt Depth: (in.) Deposits Extent:  
Infiltration: **None** Pipe Seal Cond: **Cracked**

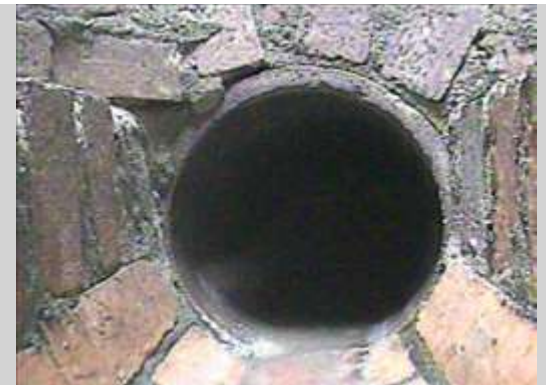
6 O'Clock Inflow

8 in. Circular Gravity Sewer  
Pipe In @ 6 O'Clock

Pipe Height: (in.) Direct  
Pipe Material: **Clay** ☐ Pipe Lined  
Invert Depth: **7.20** (ft.) Flow Characteristics: **Slow**  
Deposits: ☒ None ☐ Mud ☐ Sludge ☐ Debris ☐ Grease  
Silt Depth: (in.) Deposits Extent:  
Infiltration: **None** Pipe Seal Cond: **Cracked**
